OV-1 ACCIDENT SUMMARY

1 July 1963 through 30 June 1966

Investigation and Engineering Division
Engineering Branch

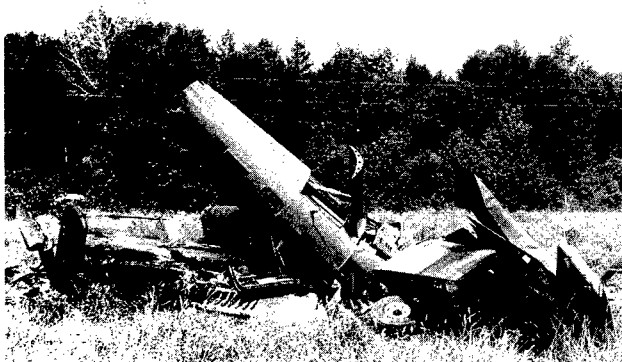
08113

08113—Aircraft struck two 3/8" ground cables located above high tension electrical power lines. The wires broke and aircraft hit a 40-foot pine tree, coming to rest in the center of a pond, and scattering debris throughout the pond and 55 yards up the side of a hill. Caused by: 1. Aircraft flying into 3/8" steel ground cables. 2. Difficulty in detecting wires from low altitude. 3. Failure to indicate location of a known flight hazard on maps used during low level flight. 4. Lack of positive instructions on gunnery procedures to be used during combined arms training exercises. 5. Conducting instruction in low level gunnery techniques to a non-gunnery qualified pilot during a combined arms training exercise.

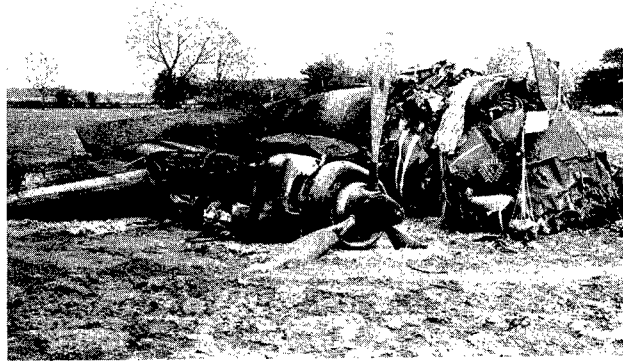
C664

C664—Aircraft departed airfield and was climbing through 4,200 feet when the No. 1 engine caught fire. Fire could not be extinguished with internal fire bottles. Both the instructor pilot and pilot made a safe ejection at 1,600 feet and received only minor injuries. The primary cause of this accident was a fire in the area of the No. 1 engine caused by misalignment of the dowel pin located in the No. 4 bearing pump housing and retainer ring, causing pressurization of the No. 3 and 4 bearing package. Pressurization resulted from inability of the front pump located forward of No. 3 bearing to evacuate the additional oil. The oil was then forced between the carbon seal and the power turbine stub shaft seal journal. This resulted in the erosion of the carbon seal, loss of lubrication, and subsequent failure of the No. 3 and 4 bearings.

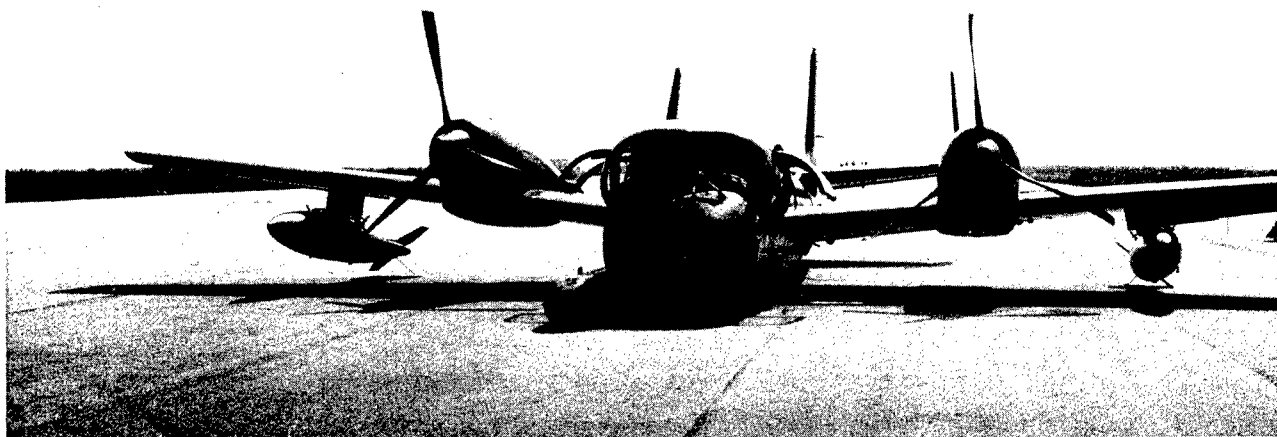
E421

E421—On completion of a short field landing, takeoff was attempted with approximately 3,600 feet of runway remaining. At an undetermined point in the

takeoff sequence, No. 1 engine failed. Aircraft struck the tops of trees, left wing low, and crashed in an inverted position approximately 1,500 feet from end of runway. The instructor pilot received fatal injuries and the pilot received major injuries. The primary cause of this accident was failure of the left engine due to intergranular stress corrosion of the disc in the 5th stage compressor. Contributing factors were: 1. No. 1 propeller was not feathered. 2. The flight crew, for reasons unknown, most probably did not arm the auto-feather circuit. 3. Engine failure occurred at a relatively low airspeed. Coupled with the propeller not being feathered, this set up an uncontrollable flight condition.

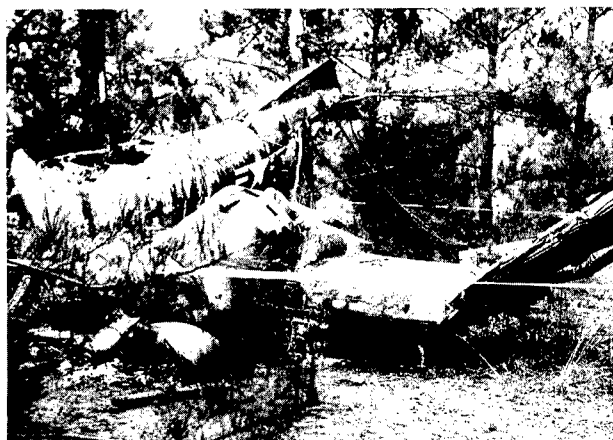
C122

C122—Aircraft was landed gear-up. Caused by failure to lower landing gear. Pilot did not use pre-landing checklist.

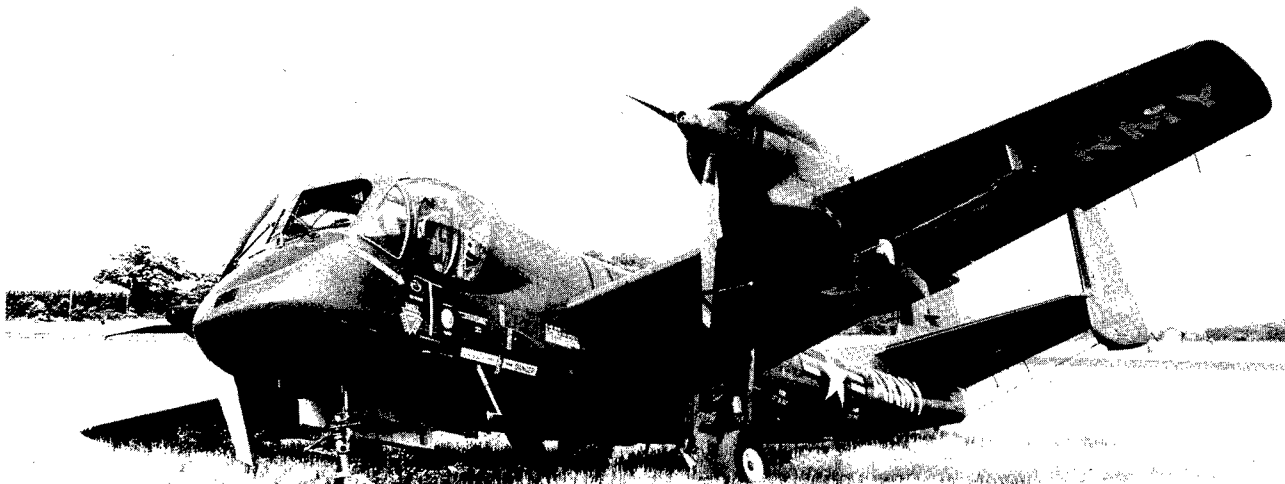
E103

E103—Aircraft was on an authorized night VFR training flight. Clearance had been obtained for a touch-and-go landing from an ILS approach. Landing was completed at approximately mid-field and power applied for takeoff. Aircraft became airborne about three-quarters of the distance down the runway. Aircraft veered to the right 45° from the takeoff heading, traveled a distance of 1,500 feet, crashed and burst into flames. Both occupants received fatal injuries. Probable cause of the accident was inadvertent feathering of the No. 2 engine propeller on takeoff. Contributing factors were: 1. Inability of the flight crew to cope with an emergency that was self-induced. 2. Lack of standardization of instructor pilot. 3. Touch-and-go landings at night.
